Merseyside Fire and Rescue Authority (MFRA)

Milverny Way, St Helens

**This design and build fire station includes extensive environmental improvements and is the last in a batch of three stations for Merseyside Fire and Rescue Authority, following the completion of Prescott and Saughall Massie.**

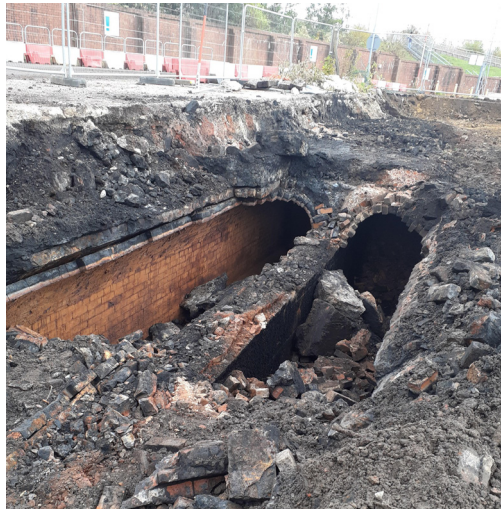
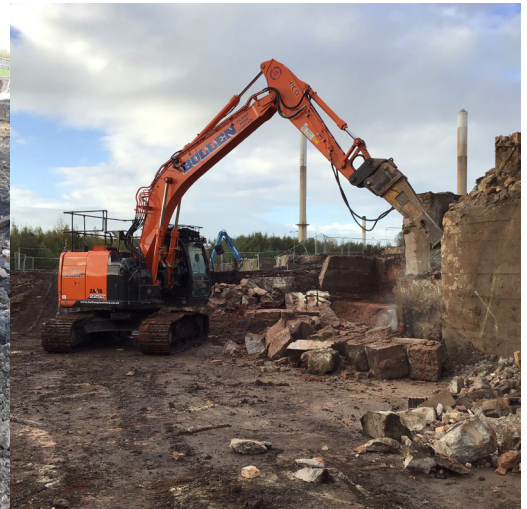
Two culverts were discovered during pre-construction (above) - one for bringing in clean air for firing the furnace, and the other for contaminated air departing the furnace. We have continued to discover tunnels (right) and shafts formed in a variety of construction methods, which are legacies remaining from the previous mining and industrial uses of the site.

Due to the unusual previous use of the site, there have been a wide variety of interesting discoveries in the ground during remediation. What was once a glass manufacturing site and coal colliery is now home to redundant furnaces, culverts, flues and chimney bases.

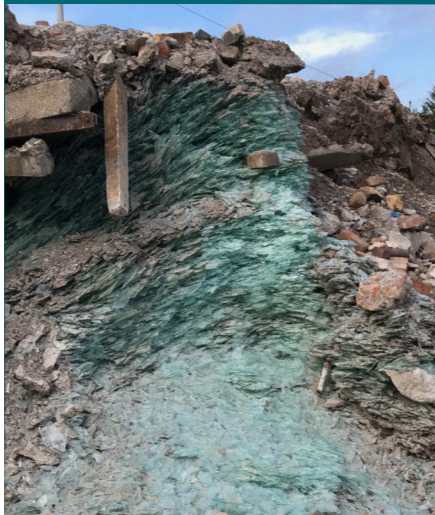
This mass of broken glass, or 'crizzle cullet', is a spectacle formed when a furnace doesn't reach the correct temperature required for glass firing, and there is excess moisture or other contaminants present ahead of production.
